# Manhole Inspection Summary

Manhole # S29MM\_019MH

Insp Date: **7/12/07 11:14 AM**

**Location** Address: **1935 RESERVOIR ST**

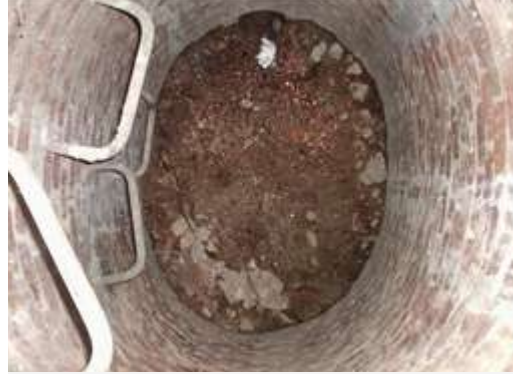
Top View

Channel debris.

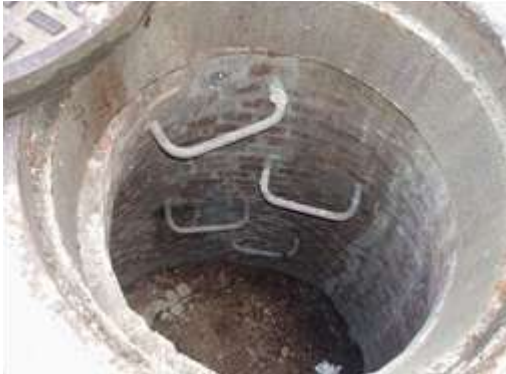
Defect

Frame leaks. Adjustment deterioration and infiltration - other side.

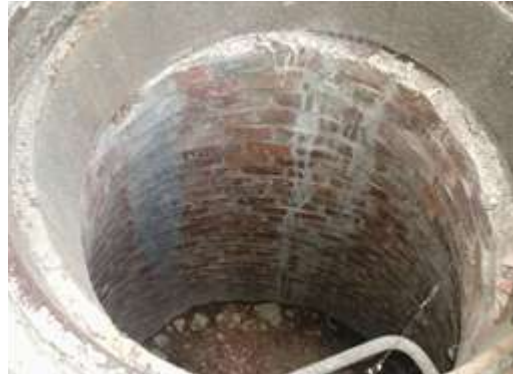
Defect

Frame leaks. Adjustment deterioration and infiltration.

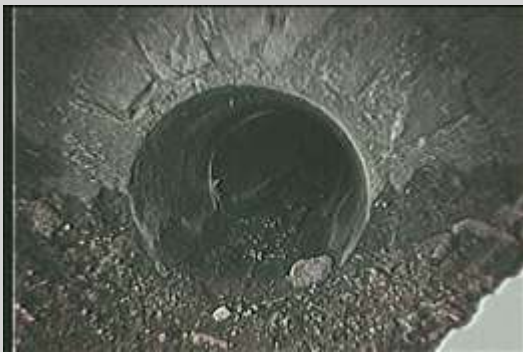
8 in. Circular Gravity Sewer  
Pipe Out @ 12 O'Clock

Deposits: ☐ None ☒ **Mud** ☐ Sludge ☒ **Debris** ☐ Grease

Silt Depth: **1** (in.) Deposits Extent: **Light**

Infiltration: **None** Pipe Seal Cond: **Roots**
